# Preliminary investigation on Cyclone Remal–induced landslides in Aizawl, Mizoram, Northeast India, on the 28th of May 2024

Article in *Landslides* · February 2025

DOI: 10.1007/s10346-025-02477-z

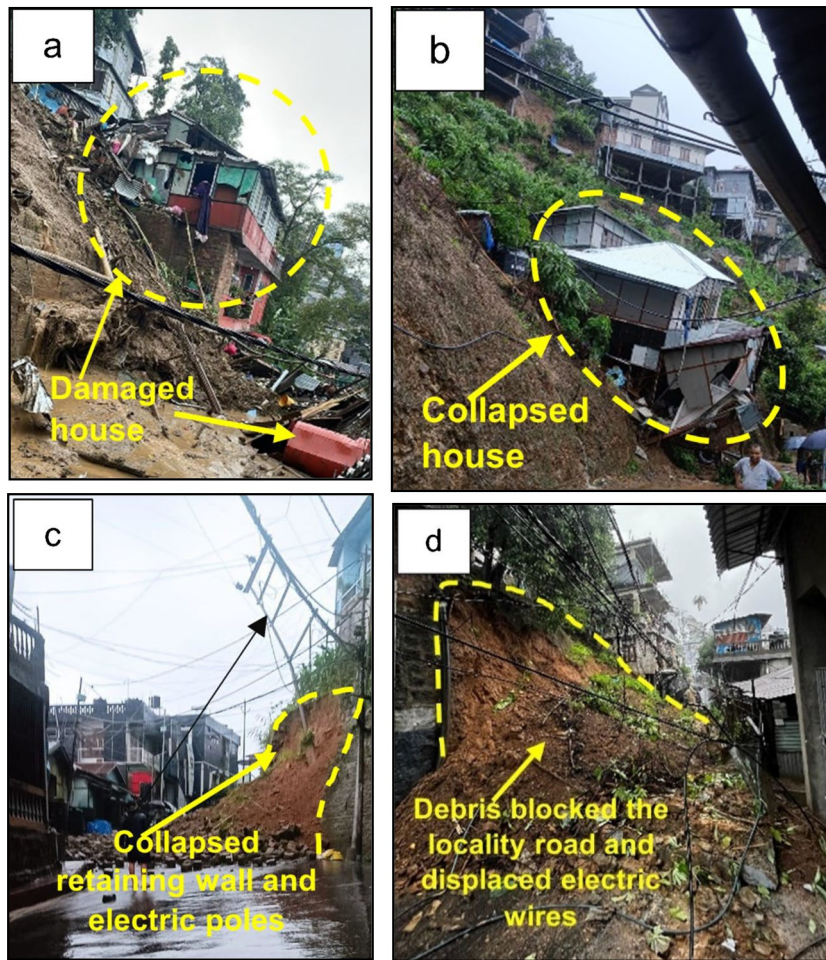
**Fig. 3** Random pictures of landslide damages in and around Aizawl. **a, b** Damage and displacement of houses caused by debris flow. **c, d** Road blocked and displacements of electric poles and wires due to collapse retaining wall

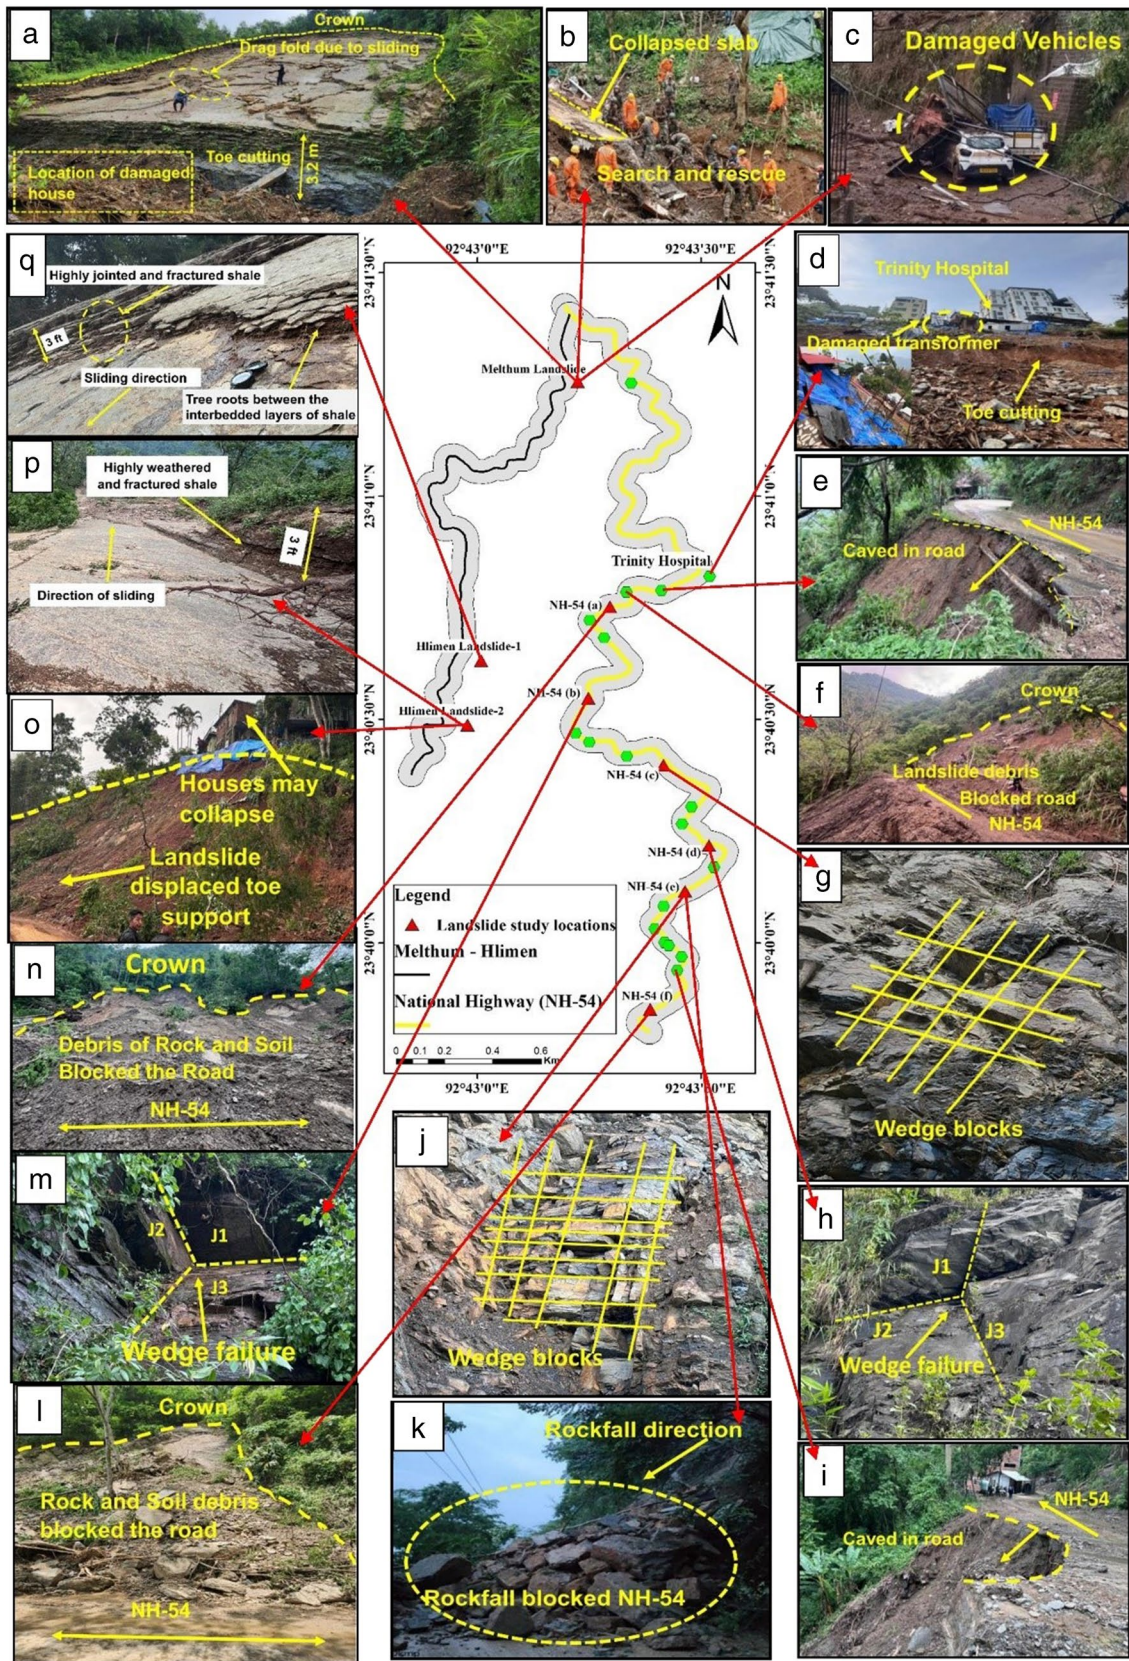
From the study, it was found that the most affected area due to the catastrophic landslide, which claimed 19 casualties, was located at Melthum ( $23^{\circ}41'16.23''\text{N}$ ,  $92^{\circ}43'15.15''\text{E}$ ). Search and rescue were

◀**Fig. 4** Landslide along Aizawl to Hualngohmun area. **a** Landslide at Melthum area. **b** The search and rescue at Melthum landslide. **c** Damaged vehicles due to rock slide in Melthum. **d** Landslide at Trinity Hospital damaged a transformer marked as a circle. **e** Caved in road along NH-54. **f** Landslide debris and mud flows in NH-54. **g** Wedge blocks observed in NH-54. **h** Wedge type failure in NH-54. **i** Caved in road at NH-54 **j** Wedge blocks observed in NH-54. **k** Debris of weathered shale and soil blocked the road **l** Rock and soil debris blocked NH-54. **m** Wedge failure observed in NH-54. **n** Debris of rock and soil in NH-54 blocking the road. **o** Landslide in Hlimen-2 showing the residential building at the crown. **p** Rock slide in Hlimen landslide-2 showing the direction of sliding, the thickness of overburden soil and highly fractured shale bed. **q** Rockslide in Hlimen landslide-1 showing the roots penetrating through the highly joint and fractured shale beds

jointly operated by the State Disaster Response Force (SDRF), the National Disaster Response Force (NDRF), and Non-Governmental Organisations (NGOs). The geology of the area constituted substantial bedrock of highly jointed and fractured sandstone overlain by a thin layer of shale about 1 m thick, capping the upper portion of the landslide scarp. The sliding area was recorded as 173 m in length and 30 m in width. The volume of displaced materials was estimated to be 5200 m<sup>3</sup>. The average soil thickness in the area is 2 ft. Our investigations revealed that constructing a house at the top portion of the landslide (Fig. 7b right corner) was carried out illegally, disregarding AMC's regulations. The landslide debris and the building slide down the slope, destroying settlements and other residential structures and properties (Fig. 7b). Four residential buildings and ten vehicles damaged by the rockslide cost around Rs. 1.6 crores. This damage emphasizes the critical importance of a hazard map and the need for strict adherence to geotechnical investigations to prevent such disasters, serving as a crucial lesson learned from past events. Kinematic analysis suggests the potential for planar and wedge sliding in the Melthum area (Table 2). The RMR assessment shows a rating of 53 (Table 1), classifying the site as "fair." There is a probability failure of 0.4 to 0.9 in the CoSMR assessment, implying stability conditions from partially stable to

About 32 landslide spots were identified along Aizawl to Hualngohmun, connecting Zoram Medical College, which falls under the National Highway (NH-54). Among these landslides, six sections (NH-54 a to f) were selected for detailed study (Fig. 1 represented in a red solid triangle inside a box of NH-54). All the landslides in this road section co-occurred on the morning of 28 May 2024. The estimated total area and volume of the landslides along this section were 7814 m<sup>2</sup> and 11,983m<sup>3</sup>, respectively. The immediate effect of the landslide near Trinity Hospital was the displacement of the Power Transformer feeding Trinity Hospital (Fig. 4d). In this

particular area, the landslide was found to be due to an unplanned, high-degree slope cutting below the hospital that was followed by the heavy rainfall of Cyclone Remal. The event invokes a threat to the patients and even to the public.

Rockfalls and debris from landslide along the road section of Aizawl-Hualngohmun (NH-54) induced blockages of the highway that disturbed transportation and rescue operations for 3 days, and hence, the victims and deceased bodies had to be carried on foot

despite the high risk of the areas. Rockslides were mainly due to the high degree of joints, which caused wedge failures (Fig. 4g, h, j, and m) and planar failure (Fig. 4i and n). The landslides result in the caving of the roads, making them difficult and dangerous for movement (Fig. 4e and i).

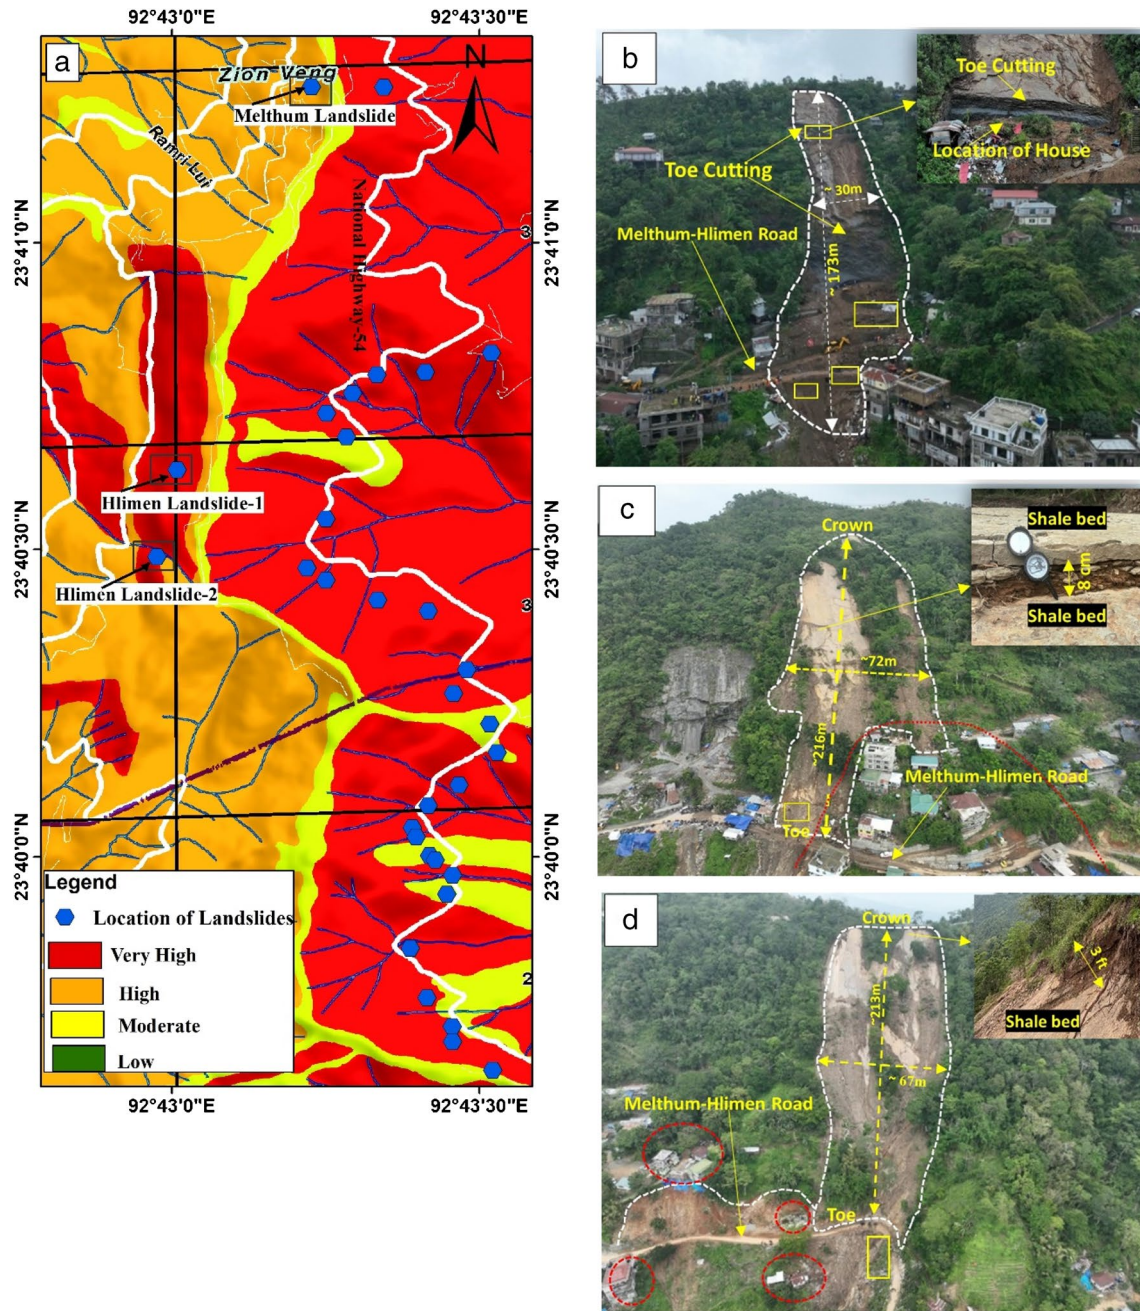
The landslide at Hlimen-1 (23°40'37.36"N, 92°43'2.38"E) measures a length of 216 m and a width of 72 m (Fig. 7c). It has been observed that the soil thickness above the layer ranges from 2 to 4 ft. The estimated landslide volume was 17,280 m<sup>3</sup>. Tragically, six lives were lost, with six vehicles and two residential buildings completely damaged, and the nearby houses were evacuated due to the high risk of failure, as indicated by the red dotted lines in Fig. 7c. The total assessed value of the damaged property was approximately Rs.64.3 lakhs. It was observed that the current state of instability is meta-stable due to the presence of debris and vegetation on the way to failure along the slope. There is a probability of planar, wedge, and toppling failure with a maximum chance of planar failure. Based on the RMR value, the rock mass can be classified under the "fair" class (Table 1) and shows a probability failure of 0.4 to 0.9 under the CoSMR assessment (Table 2). Based on Franklin and Chandra 1972, the weathering durability of rock observed in Hlimen-2 can be classified as medium durability with a durability percentage of 74.27 (Table 3).

In Hlimen landslide-2 (23°40'28.7"N, 92°43'0.19"E), houses were damaged with no casualties, and the nearby houses evacuated were marked circle in Fig. 7d. This landslide has a length of 213 m and a width of 67 m. The sliding volume was estimated to be 42,813 m<sup>3</sup>. Four residential buildings and seven vehicles were destroyed. The total cost of damage in Hlimen landslide-2 is estimated at Rs. 1.17 crores. Groundwater seepage has been detected, and the thickness of the displaced shale bed measures 3 ft (Fig. 7d right corner). The possibility of planar and direct toppling failure was observed

**Fig. 7** Landslide location along Aizawl-Lunglei (NH-54) road and Melthum-Hlimen area. **a** Aizawl Landslide Hazard Map (data source: Aizawl Municipal Corporation, GeoHazards International). **b** Landslide at Melthum rectangle box mark the location of the building before the landslide. **c** Hlimen Landslide-1 rectangle box marks the location of the building before the landslide and red dotted lines are the affected area and 8 cm of highly fractured and weathered layer between shale bed. **d** Hlimen Landslide-2 one building collapsed marked with a rectangle box, red dotted lines were the affected buildings, and 3 ft thick intact portion at the crown

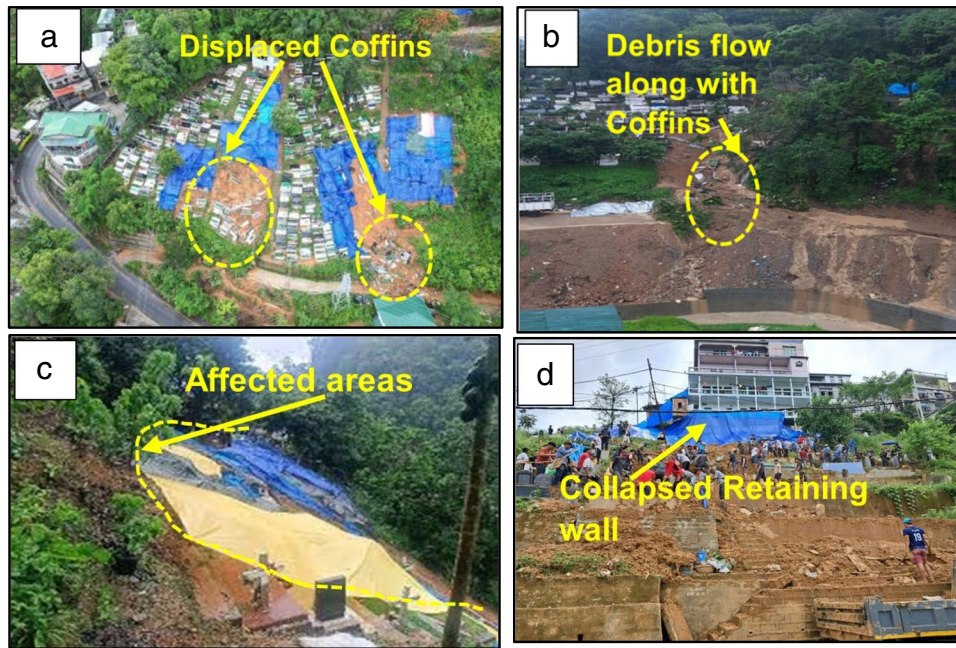
**Fig. 8** a Landslide at ITI cemetery, displaced Coffins marked as a yellow dotted circle. b Landslide at Kanan cemetery, displaced Coffins marked as yellow dotted circle. c Landslide at Kulikawn cemetery. d Landslide at Republic cemetery

On 28 May 2024, four cemetery areas in Aizawl were significantly affected by landslides. More than 200 graves were displaced at the cemetery of ITI Veng ( $23^{\circ}43'10.93''\text{N}$ ,  $92^{\circ}43'59.93''\text{E}$ ) due to the heavy

rainfall of Cyclone Remal (Fig. 8a). An NGO reallocated the damaged graves and coffins. The area is covered by thick and loose soil with a high slope angle supported by only a single-laned, 4.3 m high masonry retaining wall at its toe side, which collapsed due to oversaturation of soil and improper engineering structure. Around 50 graves were displaced due to a landslide at Kanan cemetery (23°43'53.75"N, 92°42'30.43"E) (Fig. 8b). Here, the slope has an angle of 35° with a modification at the toe, featuring a 4-m-high toe cutting. It has been observed that the problem lies not with the slope cutting itself but with the poor implementation of reinforcement measures to stabilize the modified slope. Approximately 40 graves in Kulikawn cemetery (23°42'34.41"N, 92°42'58.05"E) (Fig. 8c) and 20 graves in Republic cemetery (23°43'5.76"N, 92°43'23.82"E) (Fig. 8d) were damaged due to the collapsed of retaining wall.

Heavy rainfall, improper drainage system, unplanned slope modifications, and construction of incompetent retaining walls contributed to the slope failure during heavy rainfall of Cyclone Remal. They highlighted the urgent need for comprehensive planning and mitigation measures to safeguard sacred sites and prevent further disruption.

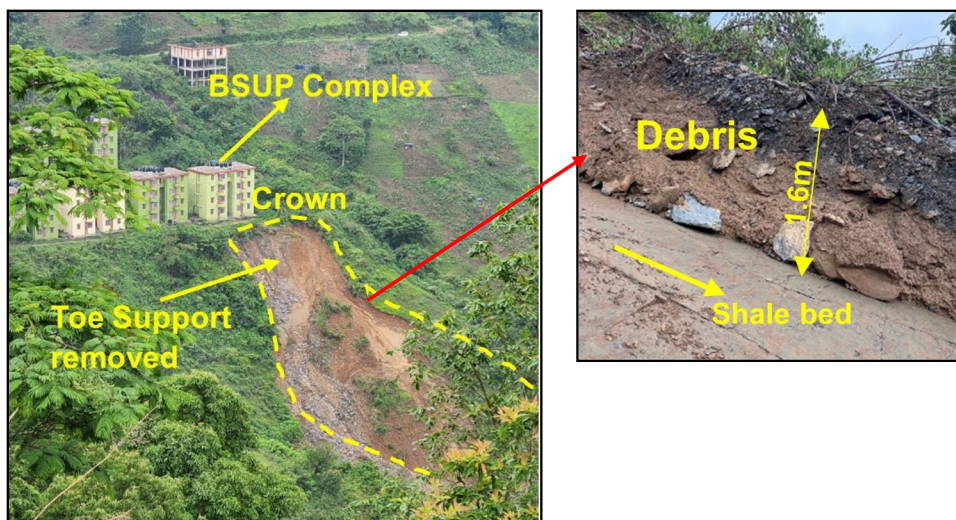
**Fig. 9** Landslide in BSUP complex, Durtlang, Aizawl. The yellow line indicates the boundary of the landslide and the overburden material above the shale bed (1.6 m thick)

In the complex of residential buildings constructed under the Basic Service to Urban Poor (BSUP) scheme at Durtlang (23°46'25.46"N, 92°44'38.34"E), 21 buildings were initially constructed. On the 3rd of July 2019, three buildings collapsed due to a landslide. Recently, on the 28th of May 2024, the lower portion of the complex, where the foundations of the lowermost section of the buildings were laid, slid due to heavy rainfall brought by Cyclone Remal (Fig. 9). The landslide is of debris type with a thickness of 1.6 m. The debris slide on the shale bed has a dip amount of 32°. The overburden material of soil forming the slope and the underlying shale bed have an adverse relationship facilitating shallow translational sliding.
