# Geotechnical investigation of landslide near Sairang Village in Aizawl district, Mizoram, India

The investigated landslide area is about 5.4 km north of Sairang village on Aizawl-Silchar road (NH-54). The length, breadth and height of slide are 110 m, 20 m and 70 m respectively. The dominant rock types exposed in the study area are sandstone, siltstone and shales and their admixtures in various proportions. The main factors for the instability of this area stems from the intersection of two sets of joints dividing the rock beds into varying dimensions and the presence of bedding shears and clay pockets/beds with swelling and shrinkage properties, decrease in the shear strength of overburden and bed rocks during rainy season due to water saturation and erosion of shaly layer by scouring action and a high hill slope. Remedial measures such as; lined catch water drains and chute for channeling surface water flow along the hill slope; lining of side drain to prevent toe erosion and also to prevent water percolation through debris. Sealing/filling of ground fractures/cracks with clayey material; breast and retaining structures to prevent toe erosion are suggested.

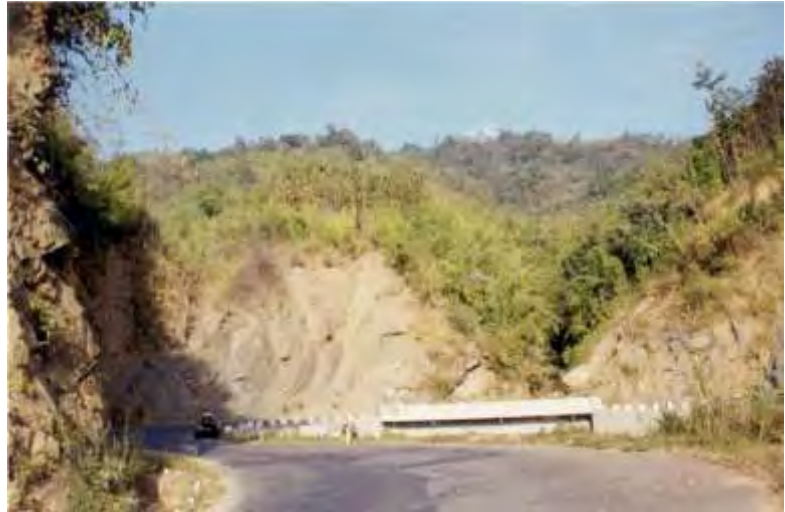
The length, breadth and height of slide are 110 m, 20 m and 70 m respectively. The material involved in the sliding are debris and small and large blocks of rocks. The supply of the material is from the 1-2 m thick overburden and 125 m high slope face composed of highly weathered and jointed rocks (Figures 1 and 2).

**Figure 1:** Synoptic view of the study site.

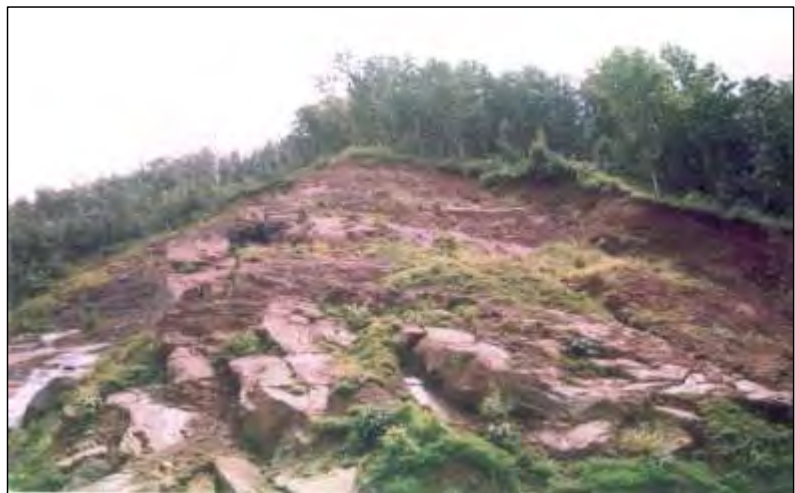
**Figure 2:** Close view of the crown area of the study site.

3. Steep hill slope at the crown part of the slide led to failure at the crown. This lead to sliding of soil debris and even bed rock as the thickness of the soil is thin at the crown.

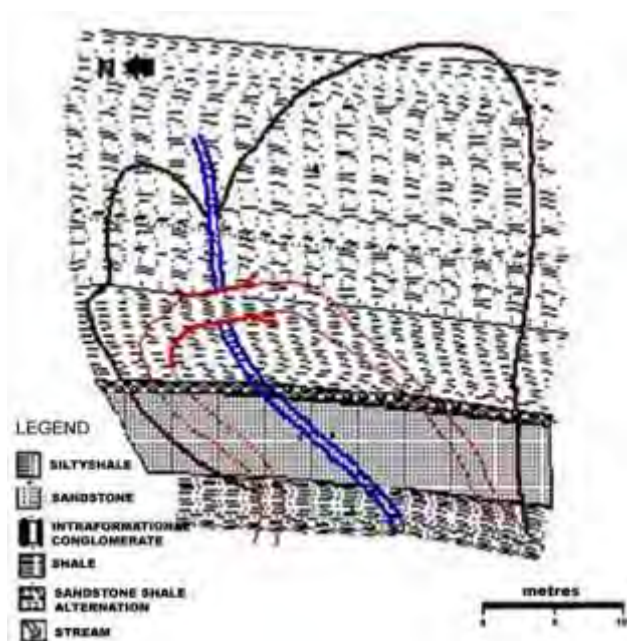
**Figure 3:** Lithological map of the landslide area.

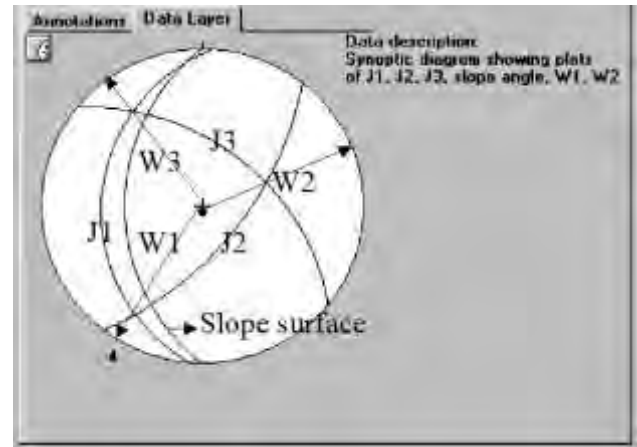
The spacing of J2 and J3 at the slided area is 1.6 m and 1 m respectively. The joint openings of J2 and J3 are 3-5 mm and 2-3mm respectively. The joint surfaces of J2 and J3 are rough and rippled respectively. The stereo plot indicates planar failure because it is along the prevalent and continuous joint set (J1) dipping towards the slope (Romana, 1985). Moreover, the strike of this joint set is near parallel to the dip of the slope face and dip is less than the dip of the slope. Thus, joint set J1 (=S0) is most critical for the stability of the slope. W1 is formed by the intersection of J1 and J2, W2 by the intersection of J2 and J3 and W3 by J1 and J3.

Figure 4(d): Synoptic diagram showing plots of J2, J3, slope angle, W1, W2.

5. The stereo plot of joint sets indicates planar failure

because it is along the prevalent and continuous joint set (J1) dipping towards the slope. Moreover, the strike of this joint set is near parallel to the dip of the slope face and dip is less than the dip of the slope. Thus, joint set J1 (=S0) is most critical for the stability of the slope.
