# Preliminary investigation on Cyclone Remal–induced landslides in Aizawl, Mizoram, Northeast India, on the 28th of May 2024

Article in *Landslides* · February 2025

DOI: 10.1007/s10346-025-02477-z

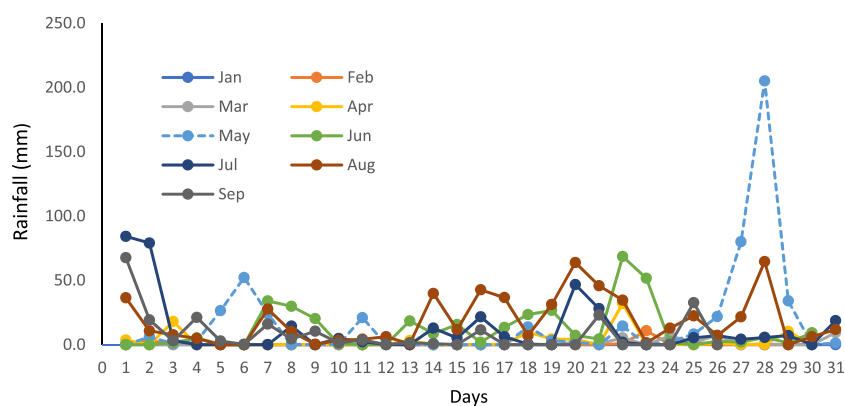
**Fig. 5** The cumulative rainfall distribution of Aizawl from January–September 2024

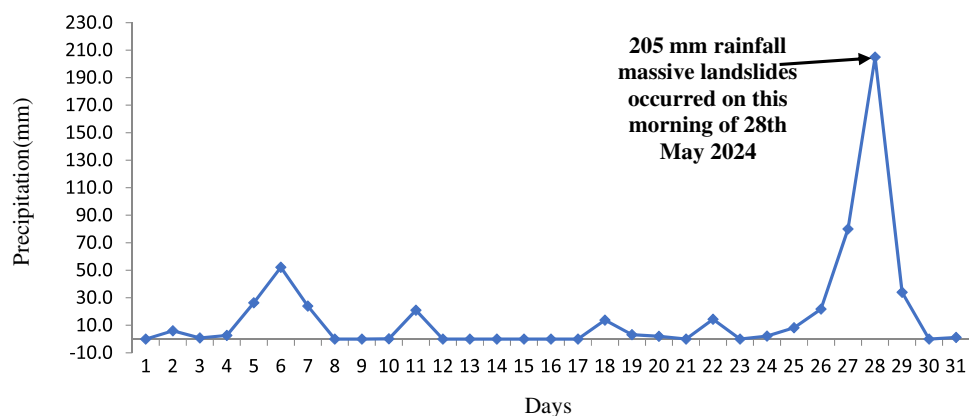
Daily rainfall data from January to September 2024 was obtained from the Directorate of Science & Technology State Meteorological Centre, the Government of Mizoram. Rainfall measurements were recorded using rain gauges located within Aizawl city, namely at Mizoram University ( $23^{\circ}44'05''\text{N}$ ,  $92^{\circ}39'57''\text{E}$ ), College Veng ( $23^{\circ}43'29''\text{N}$ ,  $92^{\circ}43'35''\text{E}$ ), Khatla ( $23^{\circ}43'35''\text{N}$ ,  $92^{\circ}42'12''\text{E}$ ), Hlimen ( $23^{\circ}40'17''\text{N}$ ,  $92^{\circ}42'40''\text{E}$ ), and Thuampui ( $23^{\circ}44'41''\text{N}$ ,  $92^{\circ}44'12''\text{E}$ ). Figure 5 illustrates the cumulative rainfall curve for this period. Rainfall reached 205 mm on 28th May, coinciding with multiple landslides around 6:30 am in various locations of Aizawl. Leading up to the rainfall event that triggered the landslides, continuous rainfall began on the 24th of May and continued through the 25th, 26th, and 27th, peaking on the 28th May with recorded precipitation amounts of 2.2 mm, 8.2 mm, 21.8 mm, 80 mm, and 205 mm respectively (Fig. 6).

**Fig. 6** The cumulative rainfall distribution for the month of May 2024
