# Geotechnical investigation of landslide near Sairang Village in Aizawl district, Mizoram, India

The investigated landslide area is about 5.4 km north of Sairang village on Aizawl-Silchar road (NH-54). The length, breadth and height of slide are 110 m, 20 m and 70 m respectively. The dominant rock types exposed in the study area are sandstone, siltstone and shales and their admixtures in various proportions. The main factors for the instability of this area stems from the intersection of two sets of joints dividing the rock beds into varying dimensions and the presence of bedding shears and clay pockets/beds with swelling and shrinkage properties, decrease in the shear strength of overburden and bed rocks during rainy season due to water saturation and erosion of shaly layer by scouring action and a high hill slope. Remedial measures such as; lined catch water drains and chute for channeling surface water flow along the hill slope; lining of side drain to prevent toe erosion and also to prevent water percolation through debris. Sealing/filling of ground fractures/cracks with clayey material; breast and retaining structures to prevent toe erosion are suggested.

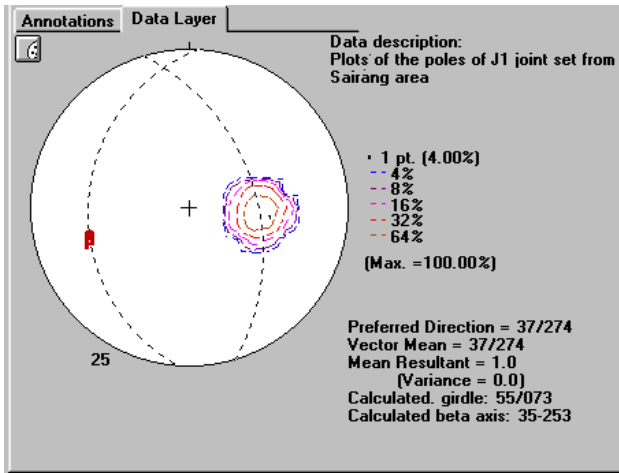
Figure 4(a): Plots of the poles of J1 joint set from study area.

About 75 readings of joint sets from the study site were recorded with the help of Brunton Compass. These were plotted in the Stereonet using GEOrient software. Three joint sets have been identified from the contour diagrams of (Figures 4(a),(b),(c)) of these joint poles. These joint sets were plotted in the stereonet along with the slope angles. Three wedges in the stereoplot of Sairang landslide (Figure 4(d)) have been identified. Rose diagram of joint sets has also been prepared to show the frequency of occurrence of joints (Figure 4(e)). The atti-
